# **TINERGY** Your Energy Audit

Jeff Friesen 813 Fifth Ave, Lyons, CO 80540 303-555-1212 jeff@jefffriesen.com

Audit Date October 22, 2012

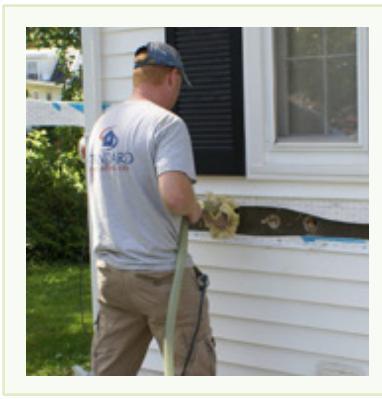
#### You have ZERO insulation in your walls!

Typical among homes of this age, there is no insulation in the walls. By "dense packing" cellulose insulation in your wall cavities, air leaks and drafts will be dramatically reduced. To install the insulation, contractors will lightly pry up a few rows of siding of on your house and temporarily remove it. They will then drill a 2" hole in the sheathing for every wall cavity. A blower pushes cellulose insulation at high speed through a hose into the holes, filling the wall cavity. Great care is taken to ensure the cellulose fills into every part of the wall.

Because there is no insulation in your walls, they create a sense of extreme discomfort in your home. The insulation value of your walls is about the same as your windows, but the total surface area of walls is 4x the surface area of windows. Tackling the wall insulation will make a dramatic difference in your discomfort and will also make the house a lot quieter!

Insulating your walls can lead to a dramatic reduction in utility bills. The estimated cost shown here is for a contractor drilling small holes in the wall cavities either from the inside or outside and filling the space with cellulose, fiberglass, or even foam insulation. If it's time to replace your exterior siding, then be sure to ask your contractor about adding a layer of rigid foam underneath the new sheathing of 1" or more.

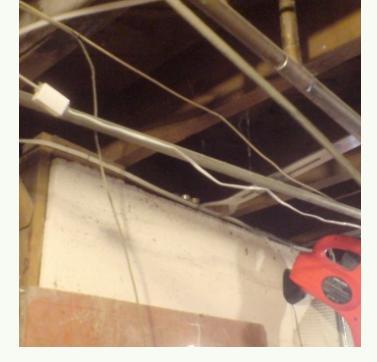
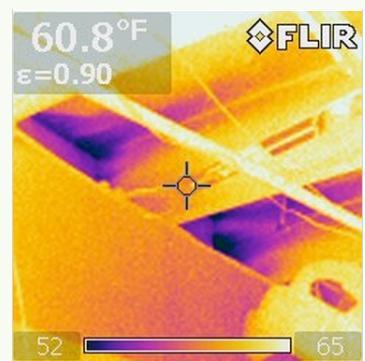
#### Air Leakage at Rim Joists:

The infrared camera suggests energy loss through air leakage and inadequate insulation at foundation rim. The same issue continues in the crawlspaces as well. Although this will be an involved improvement, it will likely improve savings and comfort throughout the house.

**Recommended Actions:** Caulk, repair, and seal holes, gaps behind trim, ceiling fixtures, etc Repair glazing and weather stripping.

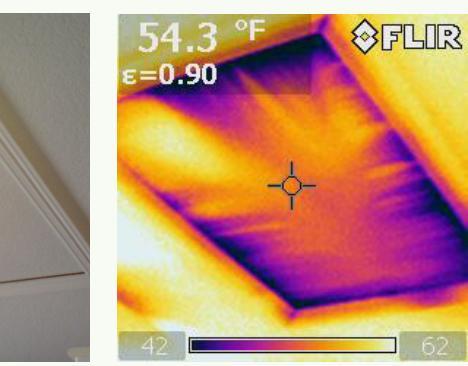
#### Air Leakage at Attic Hatch:

The infrared camera suggests a poorly sealed and uninsulated attic hatch. The outside air from the attic space is leaking into the living space and making the upstairs hallway extremely cold. Since this is where the thermostat is located, the furnace runs more frequently than it needs to in order to maintain a consistent temperature.

• Access needs sealing & ceiling fixtures need sealing against attic

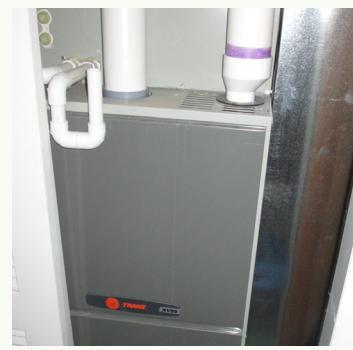
### **Heating System**

Congratulations! You have a modern high efficiency furnace. This system is a sealed combustion unit. That means that any flue gasses produced by burning the natural gas go directly outside Homeowner without the opportunity to leak into your home. Also, fresh air from the outside is brought directly to the burners in the furnace as opposed to pulling air from the house. This keeps the cold outside air in a closed loop and keeps the exhaust air outside where it belongs!

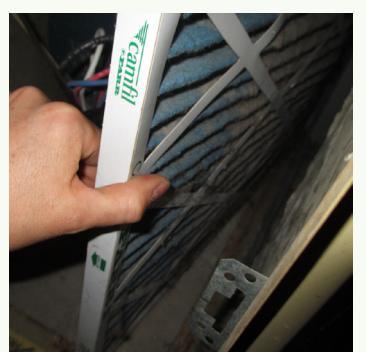
## Replace your furnace filter regularly!

Furnace filters should be changed every three months that the equipment is in use. Purchase a high quality furnace filter and inspect it monthly to ensure that it isn't full of dirt and dust. If you have pets or live in a dusty environment, you'll likely need to change the filters more often.
